# NORTHRIDGE EARTHQUAKE: LIFELINE PERFORMANCE AND POST-EARTHQUAKE RESPONSE

Technical Council on  
Lifeline Earthquake Engineering,  
American Society of Civil Engineers

Edited by Anshel J. Schiff

April 1997

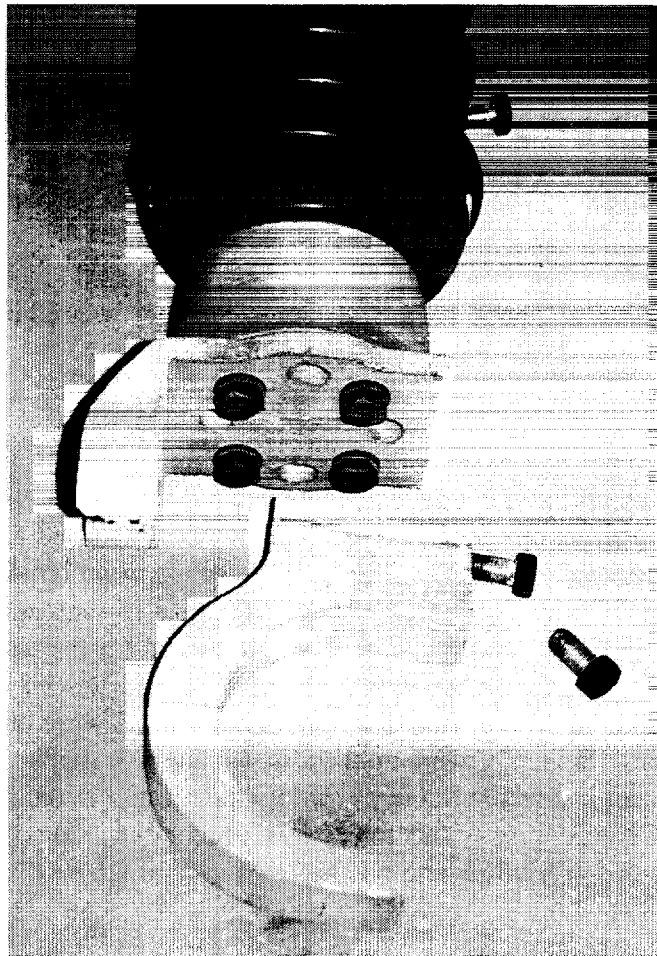
Many of the substations have rigid low-voltage bus. Its performance has been poor due to brittle failure of the cast-aluminum hardware used to connect and support conductors, Fig. 3.41. To restore service, cotton rope was used to tie the bus to post insulators, thus replacing the function of the damaged hardware, Fig. 3.42. As a result of this damage, recommendations have been made that specifications for the hardware be increased to reflect the brittle failures observed.

Fig. 3.41 Cast aluminum hardware used to support low voltage bus frequently failed.

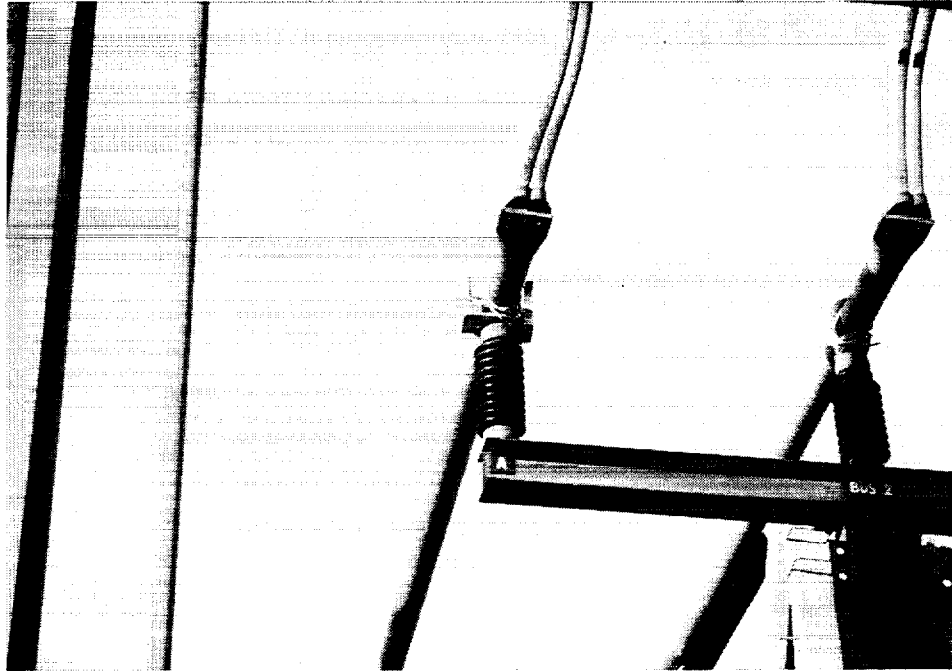
Fig.3.42 An emergency procedure was to use rope to hold bus to supports.

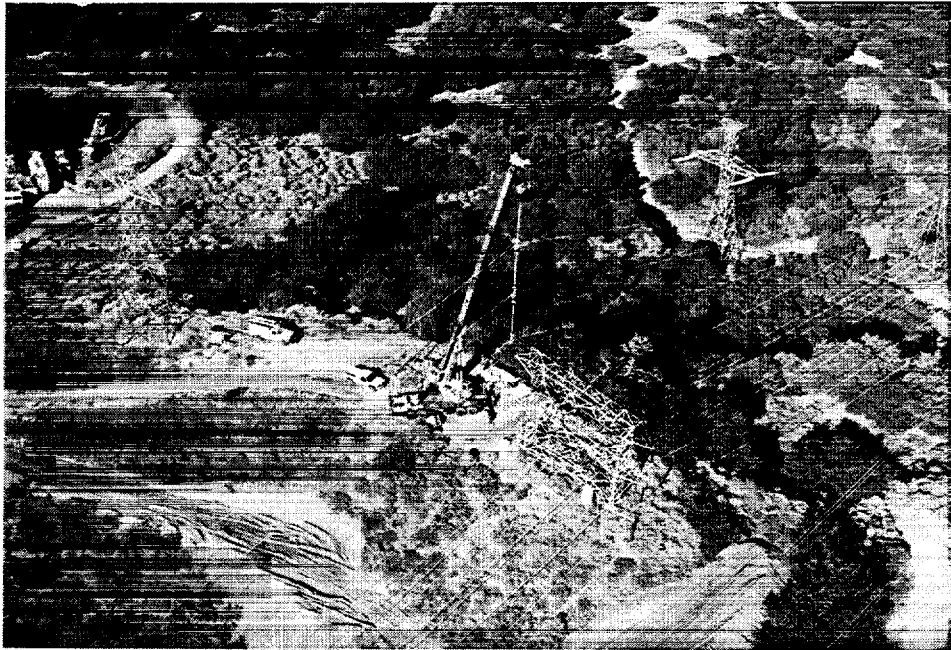
The earthquake performance of transmission towers has been very good. Several towers were damaged in this earthquake and three failures caused the loss of four circuits. A large construction crane was rigged to support one 230 kV circuit to restore a circuit to a pumped-storage facility. It was used until a replacement tower could be constructed, Fig. 3.43. Temporary supports were rigged for the other two circuits. At one substation that experienced liquefaction several large dead-end transmission towers were severely damaged. These inverted "U" shaped towers were fabricated out of plate to form large tubes. Several towers tipped slightly due to liquefaction, Fig. 3.44, and one leg of one tower had brittle fractures through its entire section near its base plate weld, Fig. 3.45. The footing of this tower was 34 feet deep. Bus support structures has a brittle fractures near welds and one had a crack through its 4" base plate.

Fig. 3.43 A crane was used to temporarily replace a failed transmission tower to restore service.

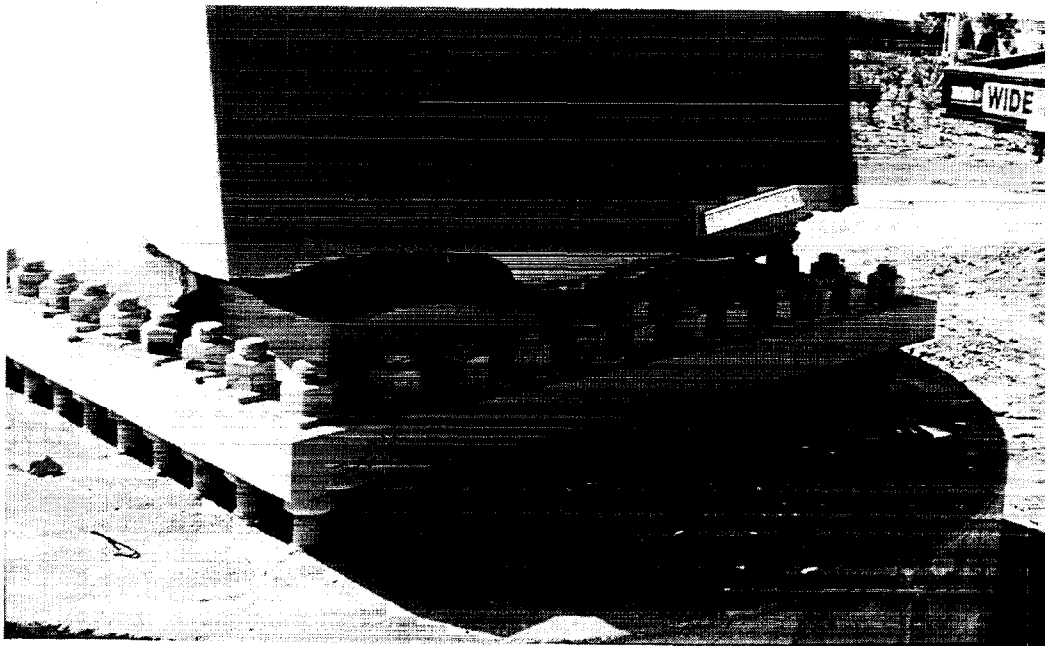
Fig. 3.45 Brittle fracture of dead-end structure associated with soil liquefaction.

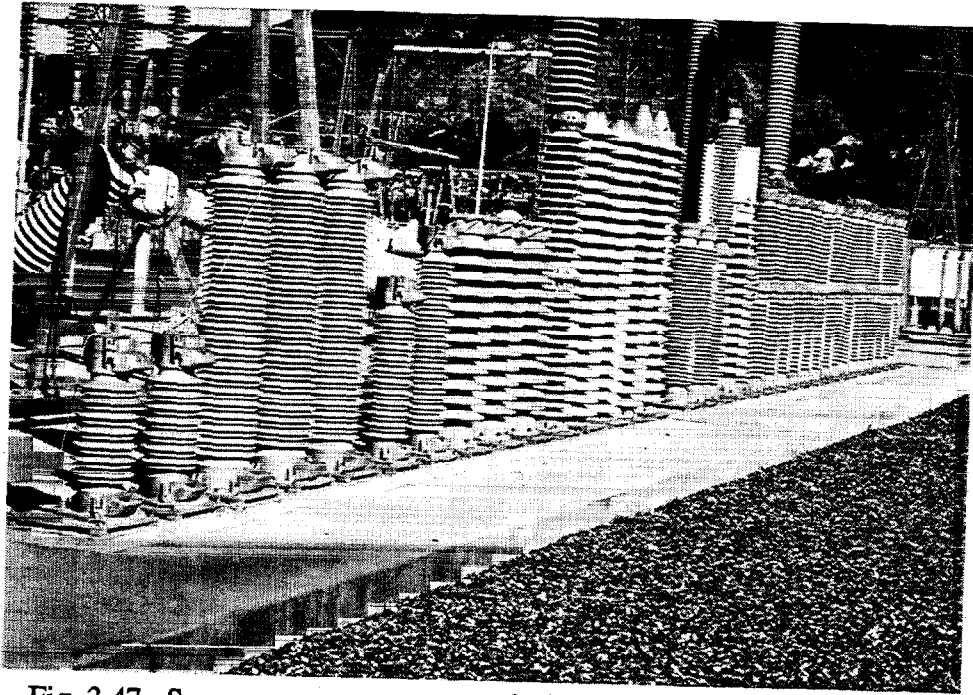
Fig. 3.47 Spare parts storage at new facility provided good protection.

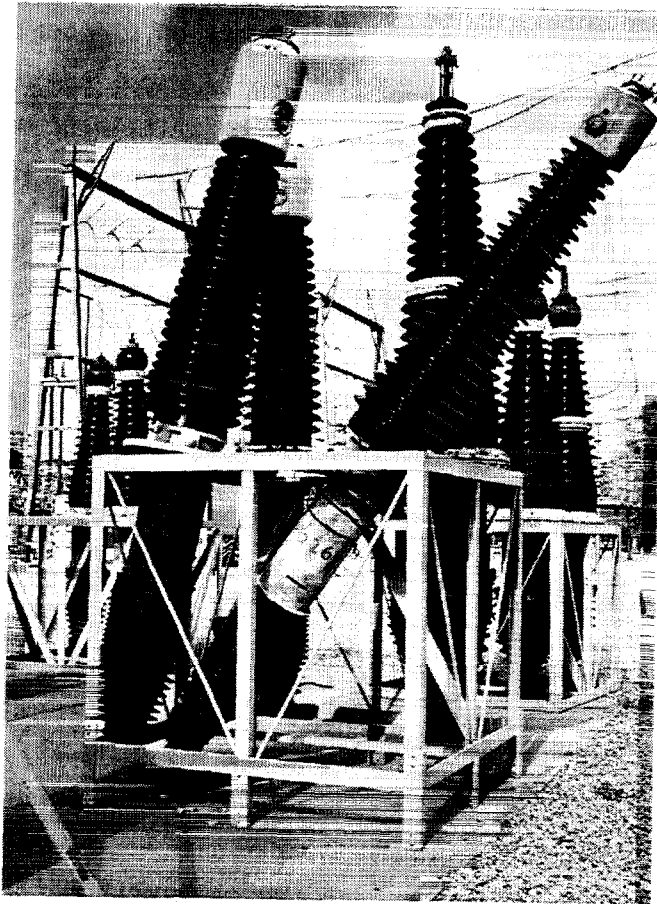
Fig. 3.48 Spare bushings stored at an older facility were not adequately anchored to their rack.

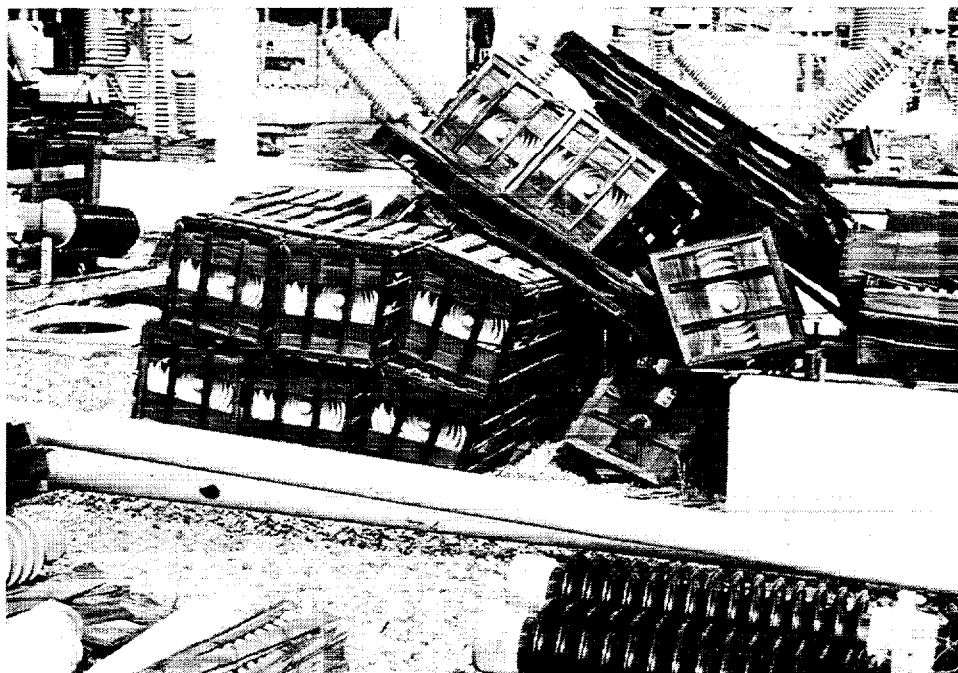
Fig. 3.49 Shipping crates provide good storage, but they deteriorate quickly in the elements.

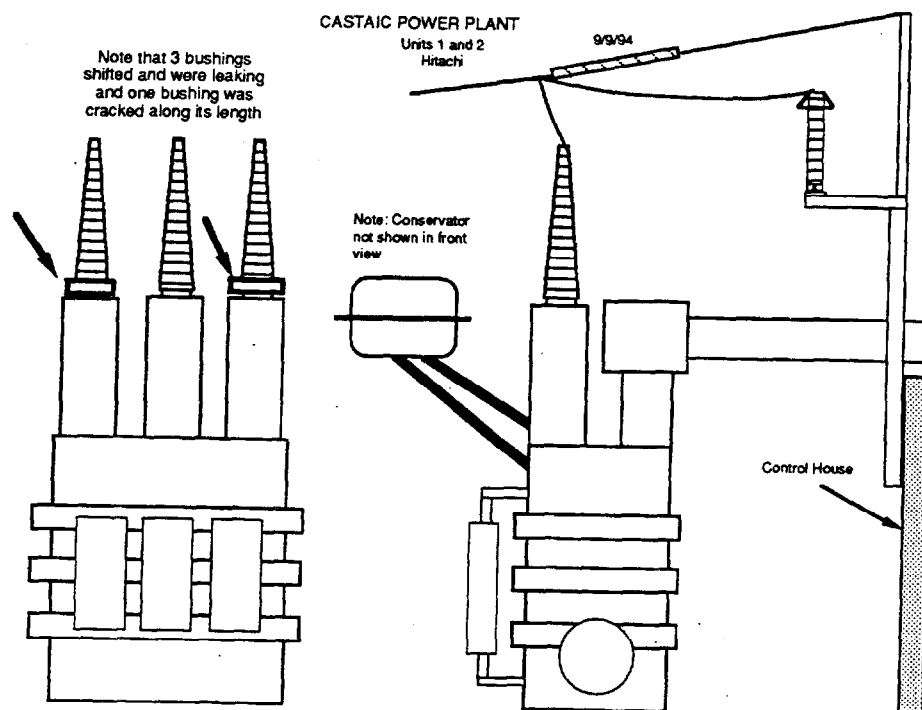
Fig.3.62 Schematic diagram showing damage to 230 kV transformers at Castaic Generating Station.

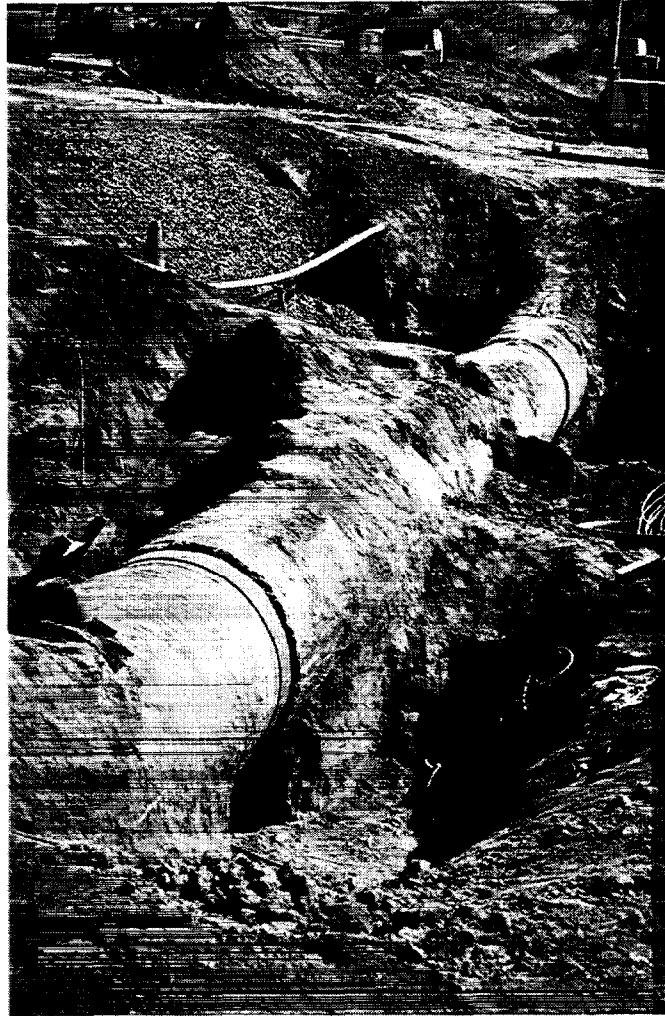
39-in. (990-mm) and 33-in (838-mm) modified prestressed concrete cylinder pipe (MPCCP). One repair occurred on the 54-in (1370-mm) MPCCP inlet pipe to the plant from Castaic Reservoir. Breaks occurred at welded fabricated compound (horizontal and vertical) bends and on long horizontal reaches where the rubber gasket joints pulled apart, Fig. 4.2.

Fig. 4.2 Excavating pulled joints and repair of 54-inch MPCCP with rubber gasket joints near Rye Canyon.

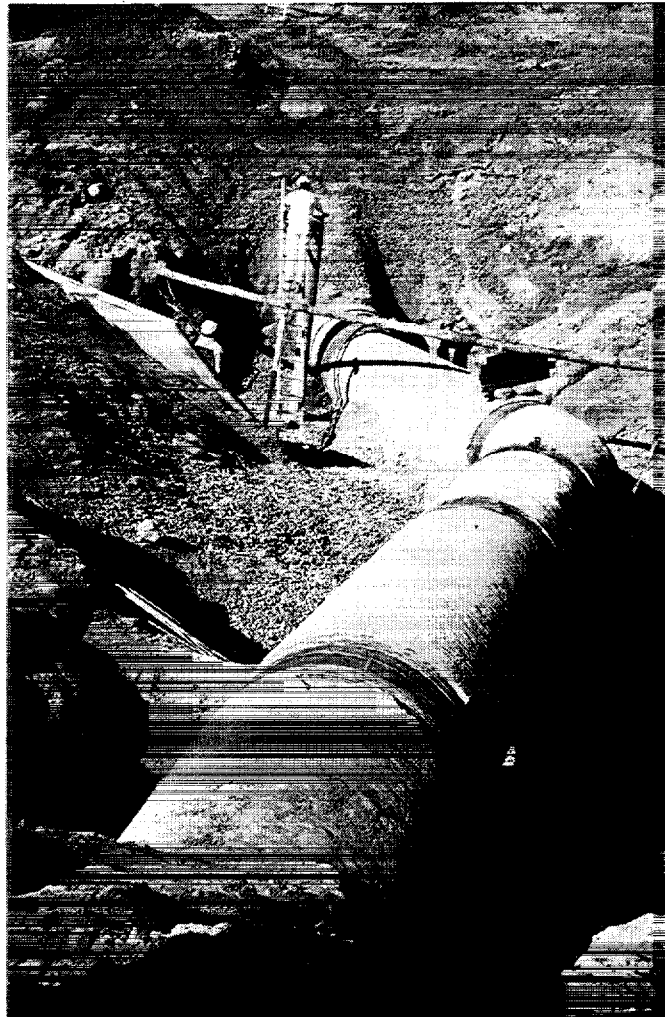
Fig. 4.3 Repaired 54-inch using contractor fabricated WSP compound bend with welded butt straps near Rye Canyon.

A pipe manufacturer fabricated new compound bend sections and a contractor welded these sections together with butt straps, Fig. 4.3. The pulled rubber gasket joints were welded in place. Backer rods were used to fill the annular space between the bell and spigot to facilitate the welding. The conduit was placed back in service March 25th. While the conduit was out of service the supply to the Santa Clarita Valley after the earthquake was supplied from local groundwater.

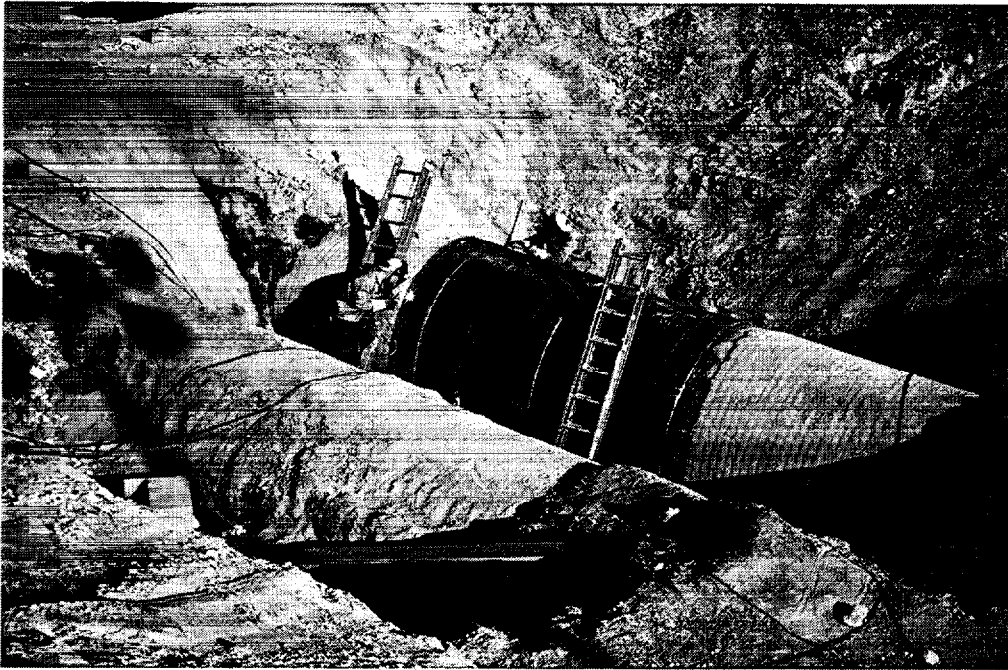
Fig. 4.5 Repaired Jensen influent 85-inch WSP, two 5 ft lengths of pipe, connected with three butt straps.

An approximately 10-feet (3.0-meters) of the damaged pipe was removed and replaced by two-5-ft (1.5-m) lengths of pipe fabricated at the MWD yard. The closure was made by three welded butt straps joints and completed the evening of January 19th, Fig. 4.5. The MWD East Valley Feeder and pumping plant was activated to provide supply from the Colorado River Aqueduct/State Water Project - East Branch to the areas in western Los Angeles County and eastern Ventura Counties, affected by this outage.

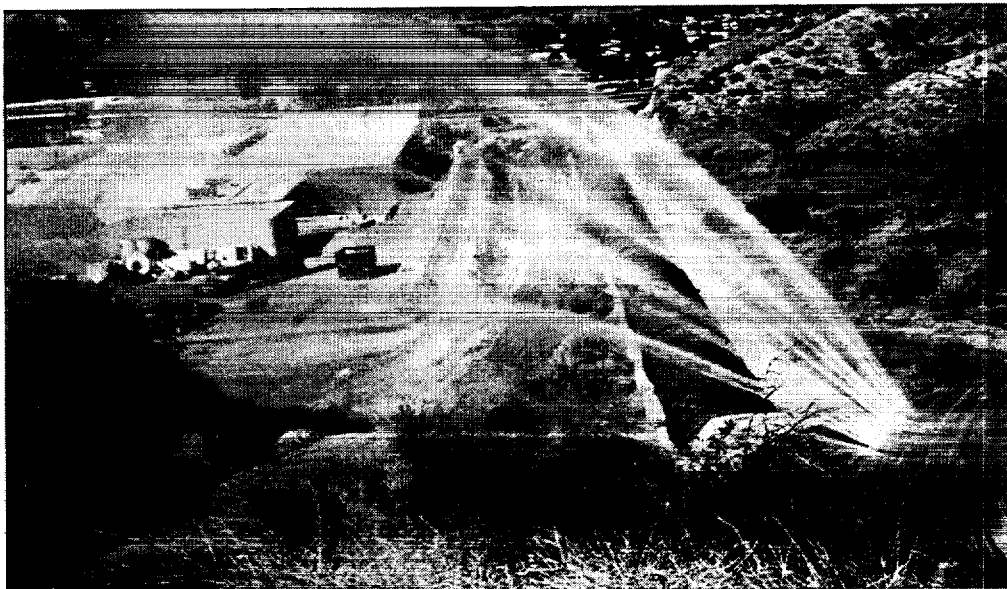
At the south end of Aqueduct No. 1 Soledad (inverted) Siphon at two locations occurred the partial cracking of the curved portion of the bell of an 120-in (3050-mm) by 3/8-in (10-mm) welded steel pipe, Fig. 4.6. The pipe was welded on the outside of a bell and spigot joint and was above ground and supported by concrete saddles, Fig. 4.7. The circumferential cracks were about 5-ft (1.5-m) long on the top of the pipe. The repair was made by removing a coupon of the damaged joints and replacing it with a welded steel plates, Fig. 4.8. At Quigley (inverted) Siphon there was split in the top of the 120-in (3050-mm) riveted steel pipe which was welded shut.

Fig. 4.6 Soledad Siphon 120-inch WSP leak. (LADWP)

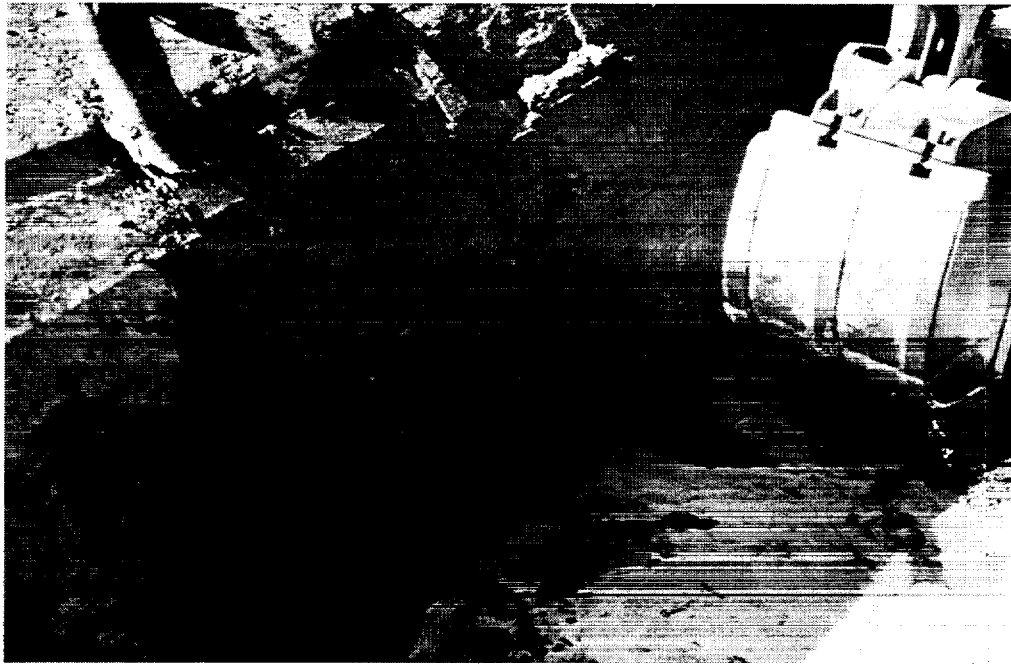
At two locations, Whitney and Elsmere Canyons, the 120-in (3050-mm) cast-in-place reinforced concrete (inverted) siphons were shattered, Fig. 4.9, temporary repairs were made by plugging the cracks from the outside. Permanent repairs were made by placing a steel liner inside the pipe and injecting the cracks with sealing compound from tapped holes in the liner from the inside of the pipe, Fig. 4.10. The steel liners were fitted with a "O" ring gasket at each end. Creek flow was a dewatering problem at Elsmere Canyon.

Fig. 4.9 Shattered Elsmere Canyon 120-inch concrete conduit. (J. Herbaugh)

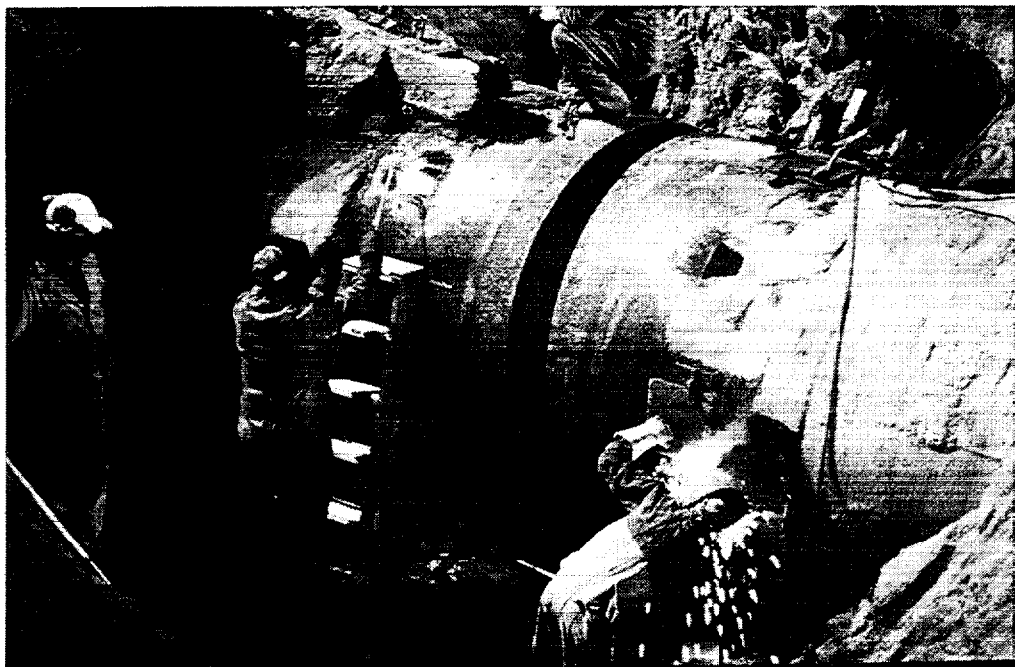
At Terminal Hill the 77-in (1955-mm) welded steel pipeline was shut down twice to repair two pulled mechanical couplings, Fig. 4.11, and an eight-inch long split in the wye branch stiffener. This required the draining and filling the pipe twice during the first week after the earthquake. The pulled couplings were temporarily repaired by welded butt straps. Permanent repair was made by the installation of double restrained mechanical couplings, Fig. 4.12. The wye branch stiffener at this location was rewelded, Fig. 4.13.

Fig. 4.11 Temporary repair in progress of 77-inch WSP pulled mechanical coupling at Terminal Hill. (LADWP)

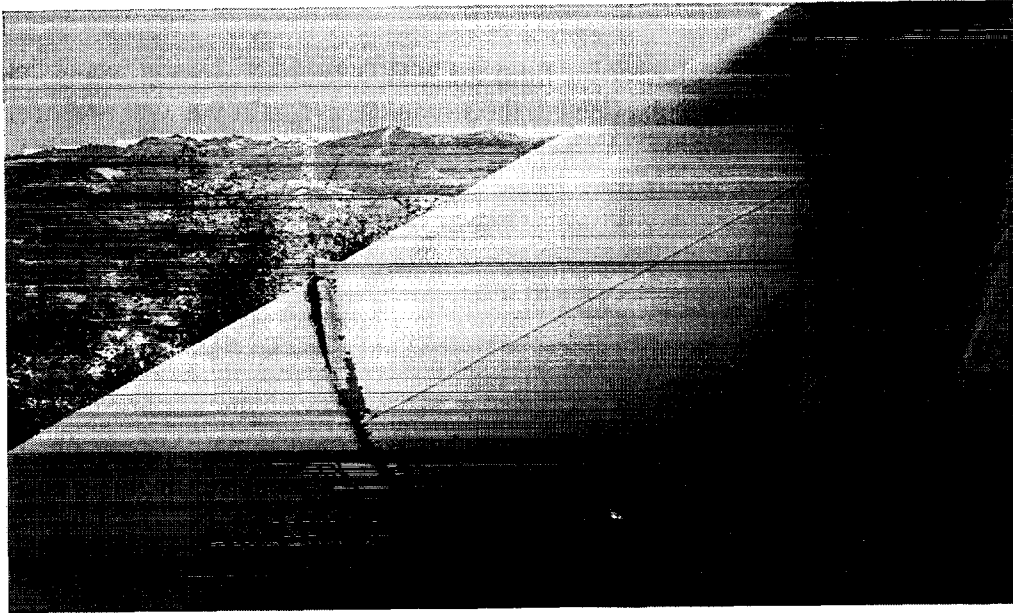
Two 6-in (130-mm) compression bulges appeared on the north slope of Terminal Hill in the 77 in (1955 mm) pipe in above ground pipe supported on concrete saddles, Fig. 4.14. This represented almost 2-feet (0.6-m) of compression in the pipeline. At these bulges there were no leaks although significant movement occurred, Fig. 4.15. At Quigley Canyon a circumferential tear in the top of the buried 77-in (1955-mm) welded steel pipe was repaired by welding a interior patch plate.

Fig. 4.14 North slope of Terminal Hill 77-inch WSP supported on concrete saddles.

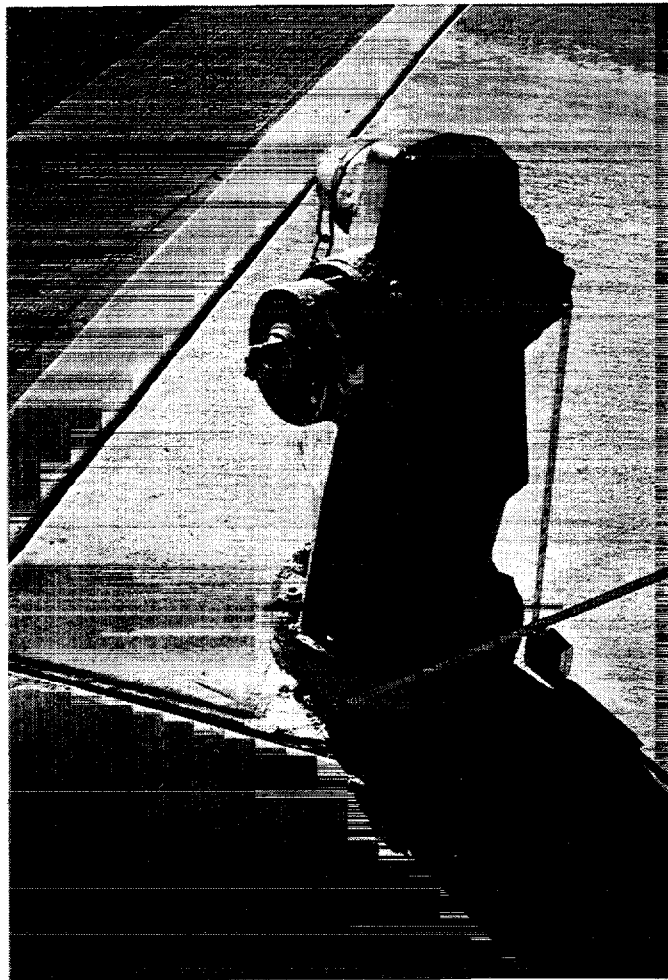
Fig. 4.16 Typical broken fire hydrant.

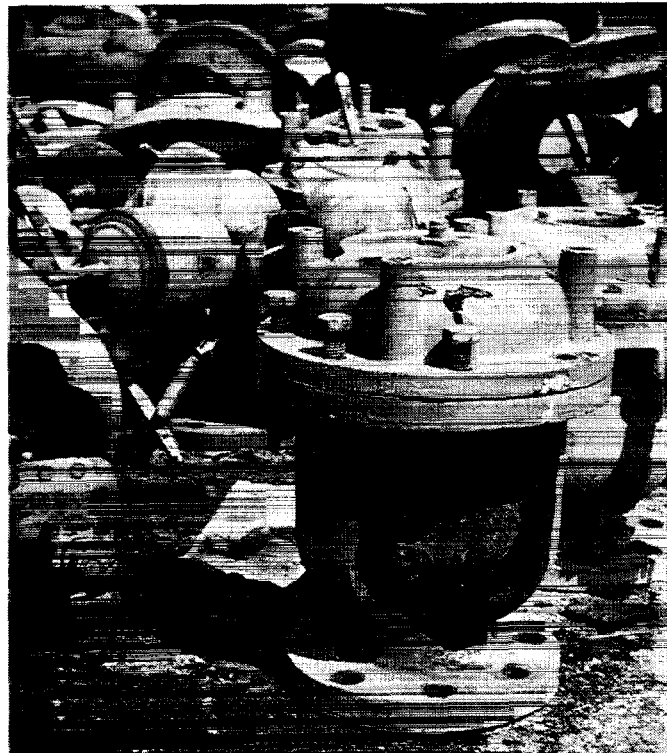
Fig. 4.18 Broken air and vacuum valves.

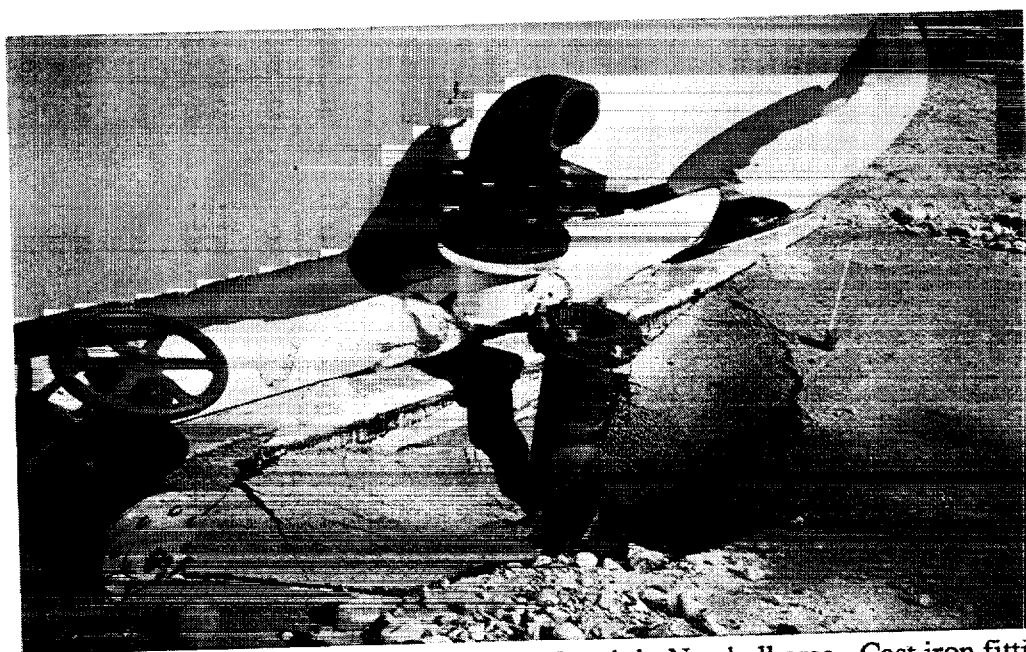
Fig. 4.21 Damaged 0.85 mg welded steel tank in Newhall area. Cast iron fittings failed and tank wall is torn across elephant foot buckle. Anchor straps are concealed by the elephant foot buckle.

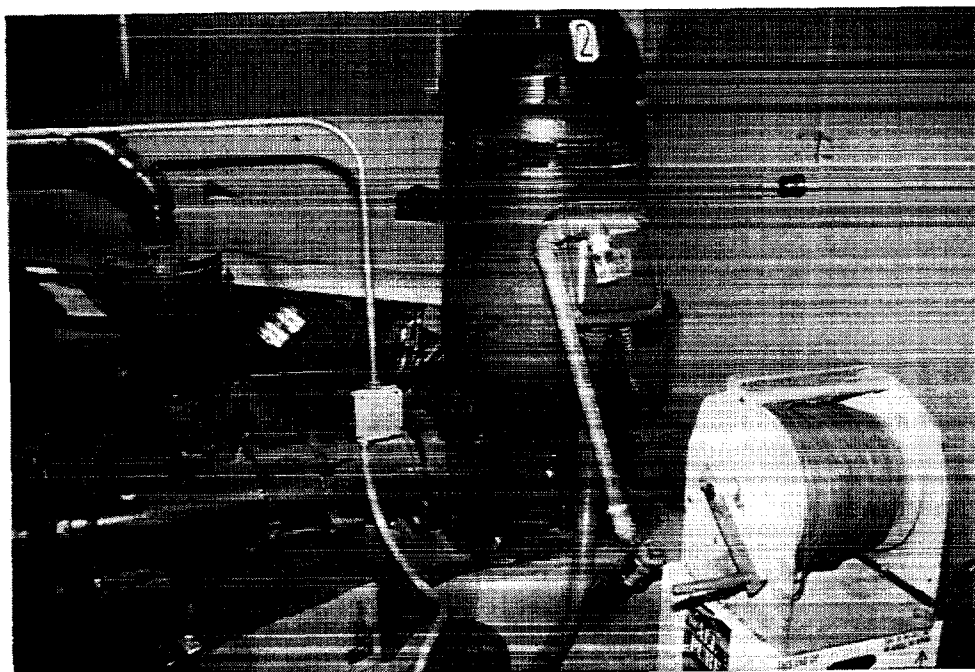
There was no reported damage to booster pumping facilities or groundwater wells, other than loss of commercial power, Fig. 4.27. Many wells did not have emergency power. Pumping stations with emergency power supply worked well. There was minor damage to the enclosures housing these facilities. The lack of damage to wells was an important alternative supply to areas who lost their imported supplies.

Fig. 4.27 This typical well pump installation had no damage.

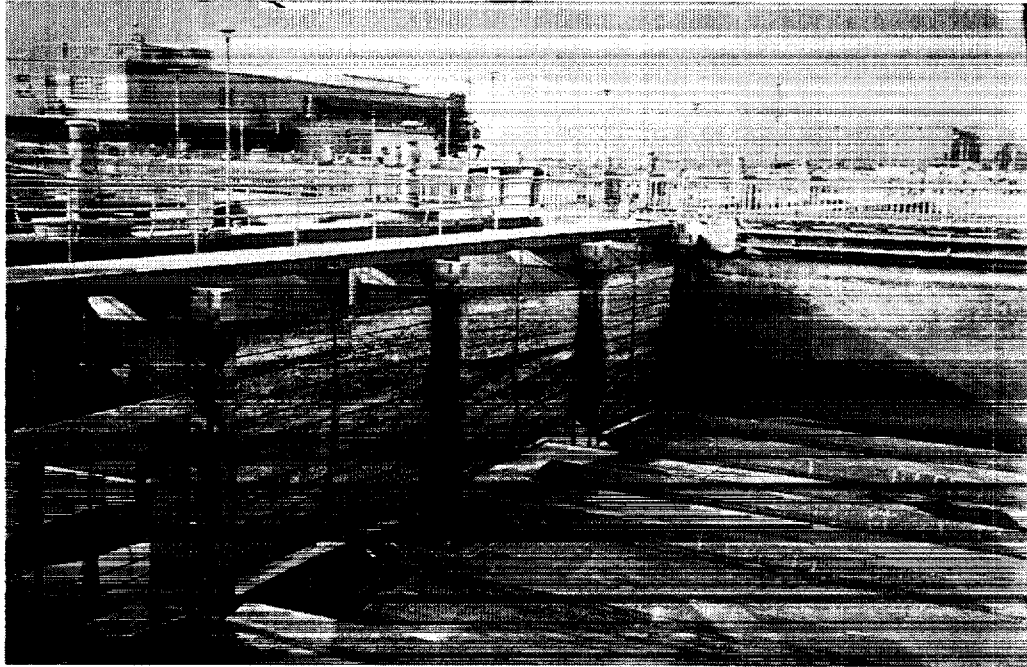
Fig. 4.31 Floating wood baffles dislodged by sloshing at water treatment plant. (MWD)

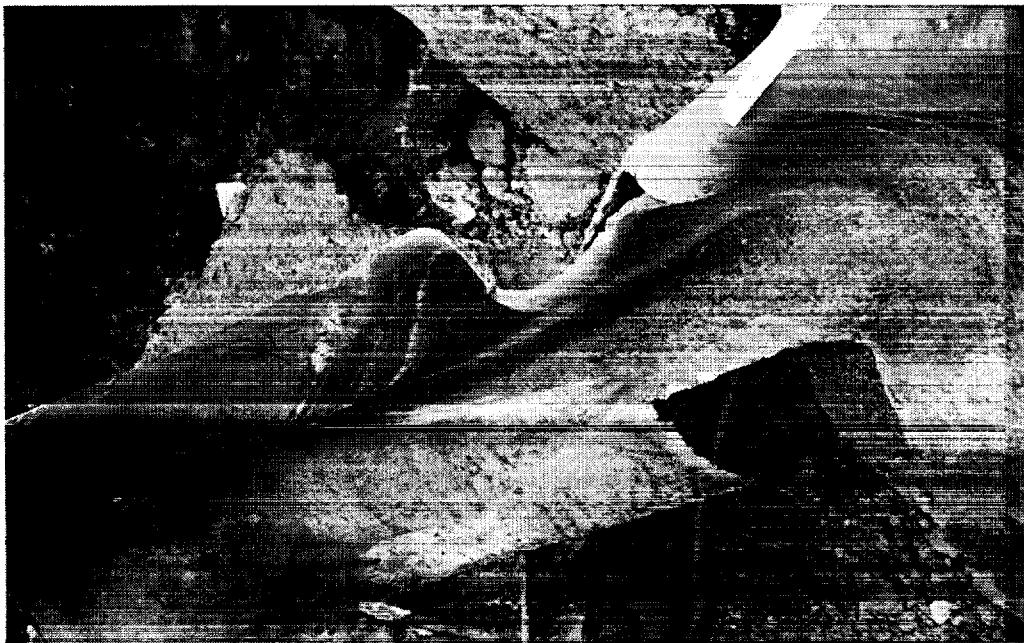
Fig. 4.34 Balboa Blvd. at Halsey St. compression zone 68-inch WSP buckled bell and spigot joint.

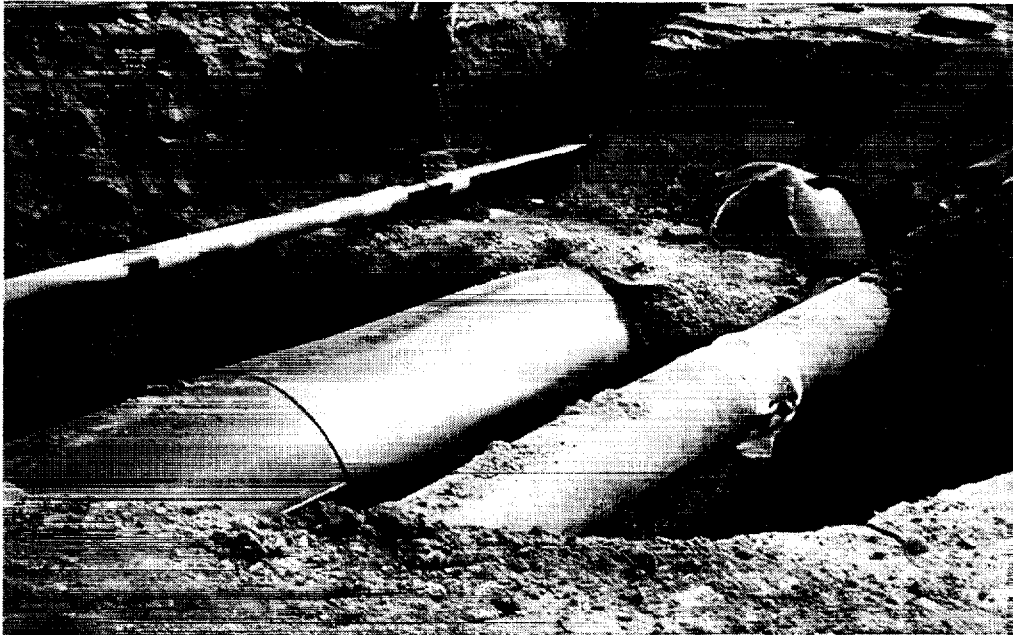
Fig. 4.37 Completed pipeline repairs at Balboa Blvd. at Halsey St.

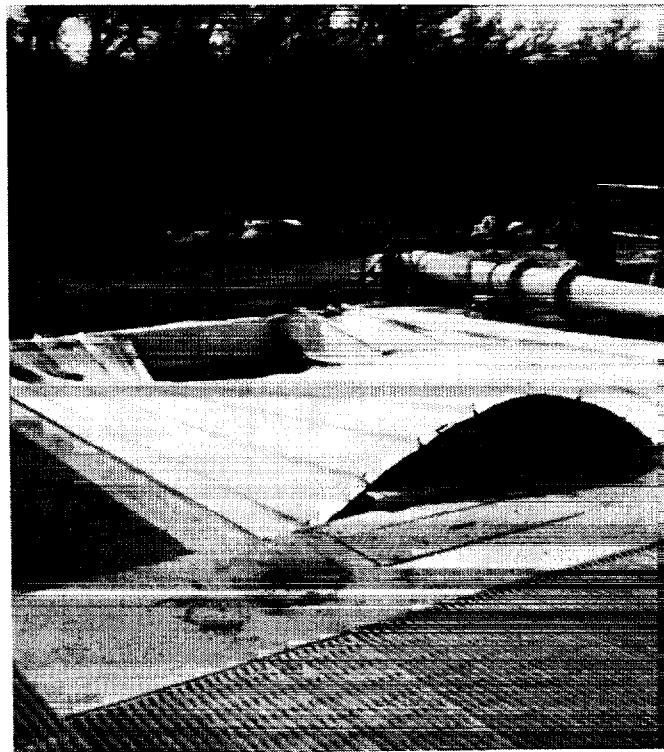
Fig. 5.2 Valencia Plant filter backwash wet well cover damage due to sloshing.  
(LA Co. SAN)

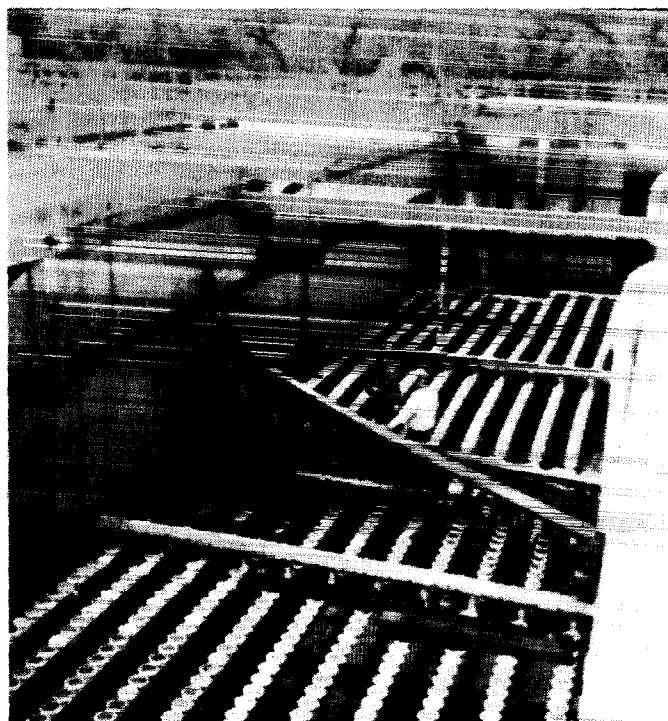
Fig. 5.3 Valencia Plant aeration tank damaged PVC aeration header and grid piping due to failure of pipe support to concrete wall. Header support moved 8 feet is laying against wall at the top of photo. (LA Co. SAN)

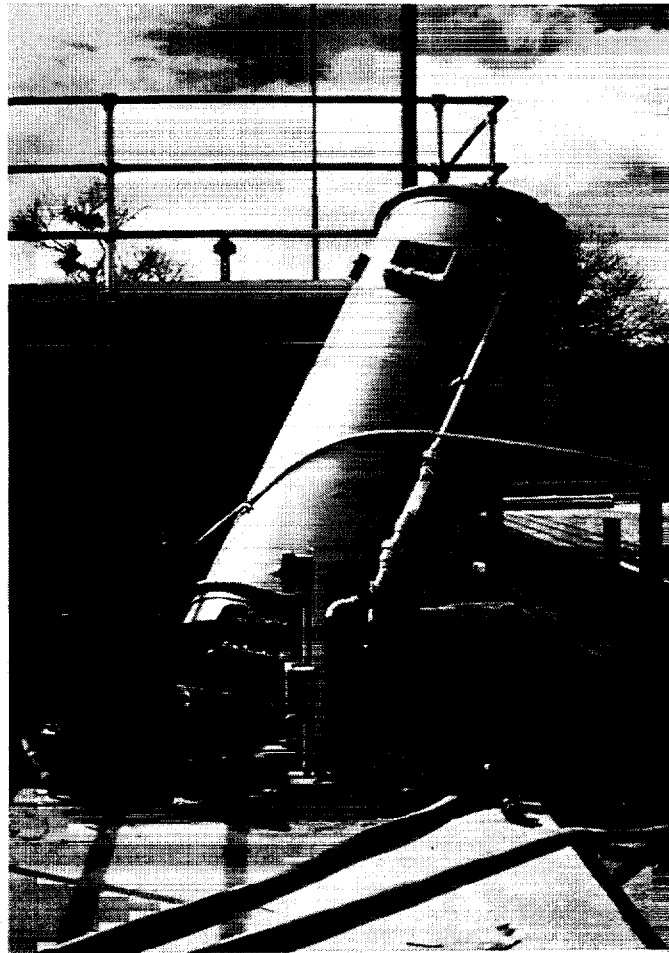
Fig. 5.4 Valencia Plant destroyed air scrubber. (LA Co. SAN)

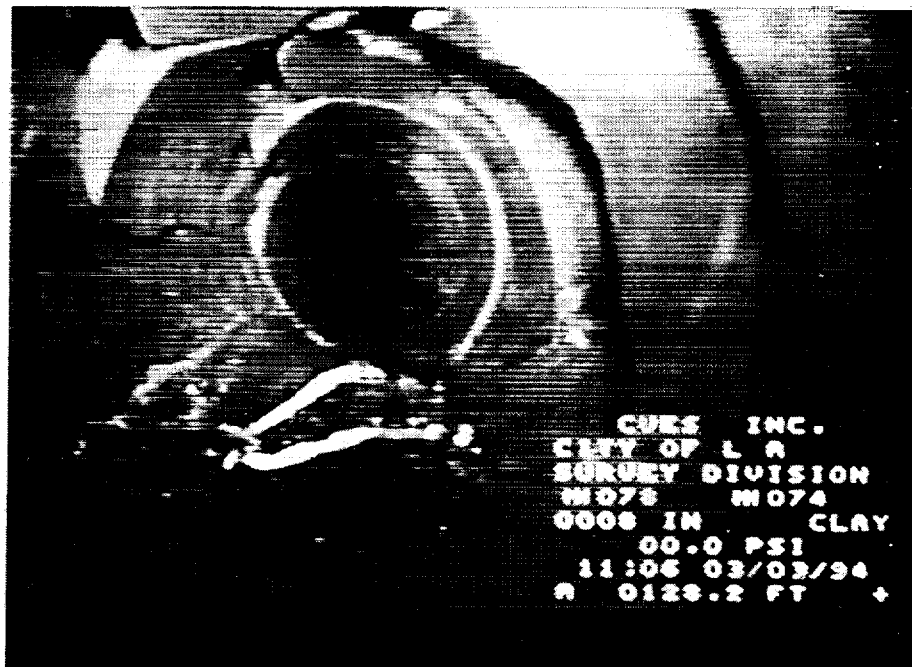
Fig. 5.7 Television photo of the interior of 8-inch VCP sewer. (LADPW)

made the repairs to the lines and service was restored. Sewer lines are normally flow by gravity. They may have been damaged, but if not obstructed will continue to flow, and show damage at a later date after a television survey (Figure 4.7).

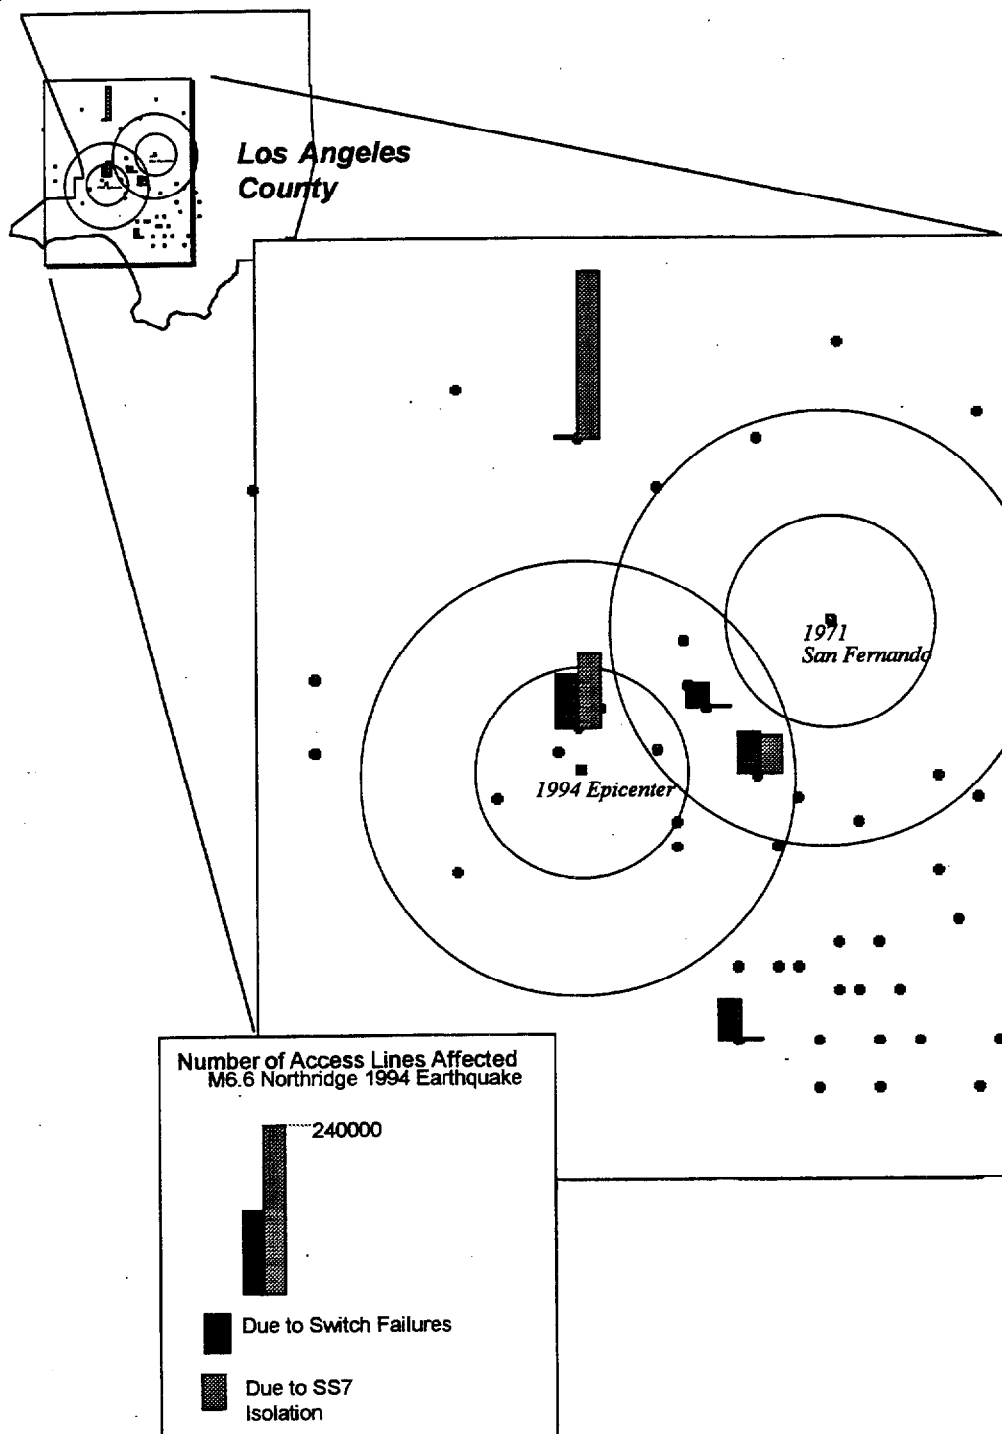
Generally speaking, the extent of outage and damage corresponds to proximity to the epicenter as Fig. 6.2 shows. Exceptions include facilities in Sherman Oaks, Newhall and Santa Monica and they can be attributed to local geologic conditions. Note that with reference to the figure, some COs are affected by switch failure only, others are affected by SS7 isolation only, and some are affected by both. The reason is that control is implemented logically through a network separate from that of transmission and switching. Interexchange switch failures occurred at a single Point-of-Presence (POP), and affected all COs in the region connected to it.

Fig. 6.2 Distribution of outages due to switch failure or SS7 isolation. The bars show the respective number of circuits affected.

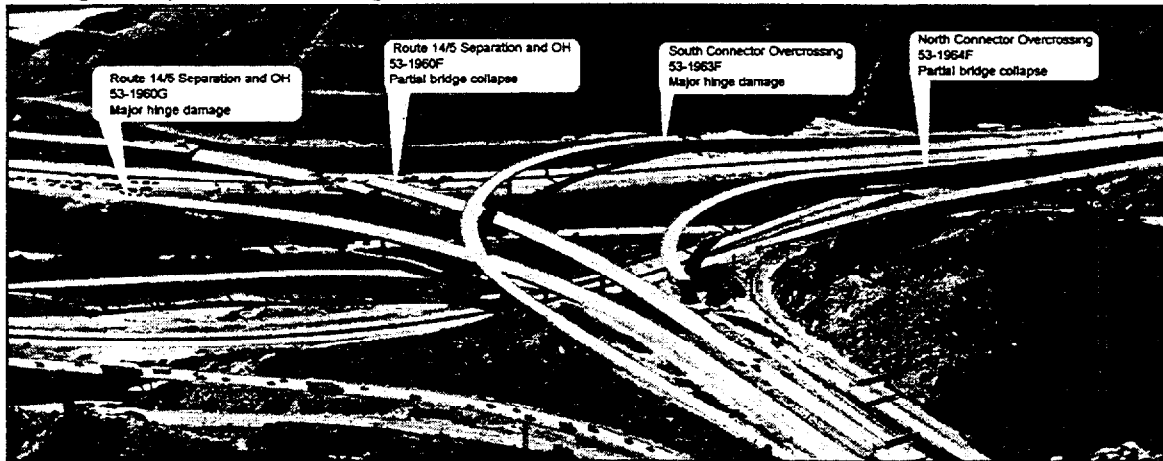
Figure 7.6. Bridge Damage at Location #2 - Route 14/5 Interchange.

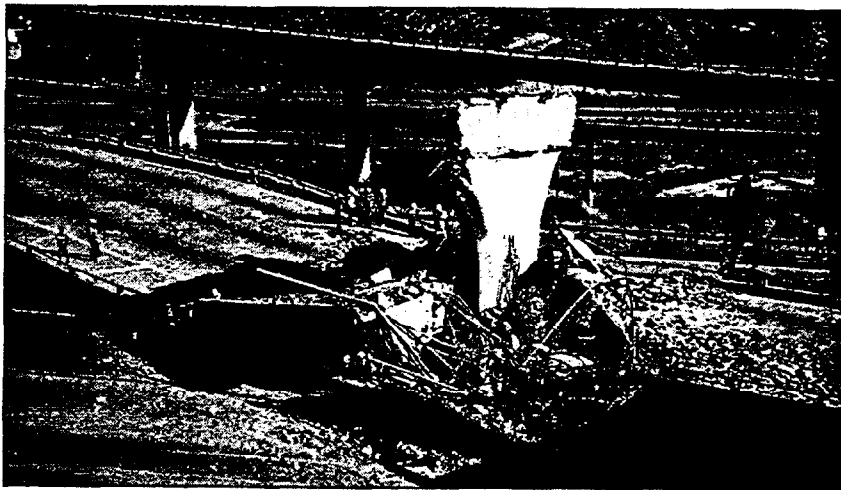
Figure 7.8. Damage at Pier #3 to Rte 14/5 Separation & OH.

damage to abutment #1 was the failure of the right shear key as the superstructure moved to the right. At pier #2 the longitudinal column reinforcement remained attached to the bent cap while the column concrete was in rubble. Pier #3 remained standing while the superstructure on both sides of pier #3 and the bent cap lay on the ground. At hinge #1, all the restrainers and equalizing bolts had failed in tension and there were concrete spalls indicating banging of the hinge.

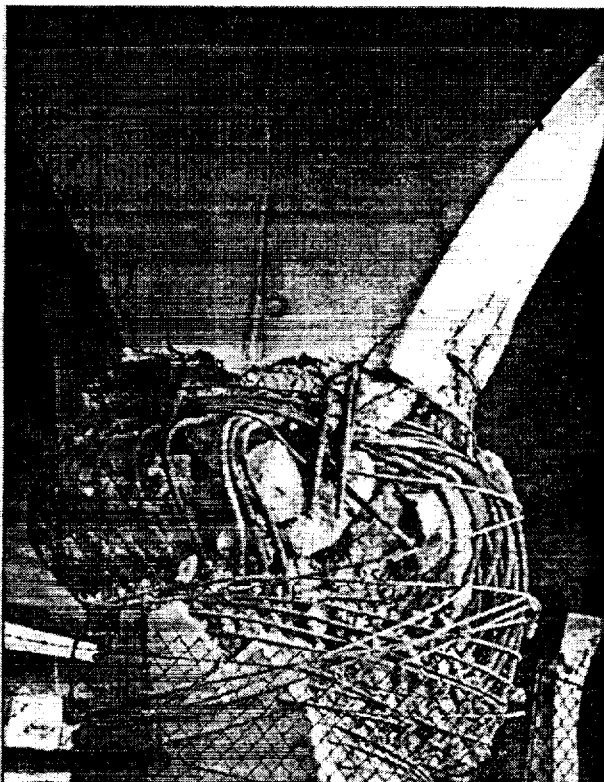
Fig 7.13 Left Bridge of Mission Gothic UC.

Both bridges suffered serious damage during the earthquake. The right bridge had a collapse of spans three and four. The columns at Bents #3 and #4 broke off below the flares, dropping the superstructure and unseating it at Abutment #4. The superstructure remained seated at Abutment #1 although there was 13 inches of transverse movement. At Bent #2, the left column also failed below the flare; however, the right column broke the bottom pin instead. The left bridge didn't collapse; however, most of the columns failed below the flare. There was two inches of transverse movement at Abutment #1 and over 10" at Abutment #4.

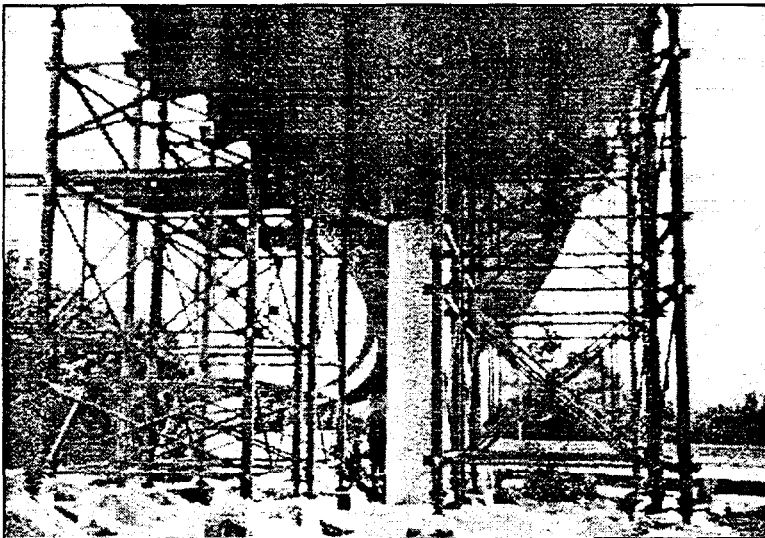
Fig 7.21. Damage to the Southeast Connector Overcrossing

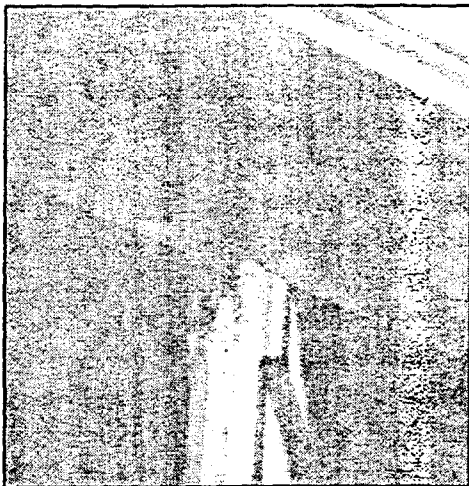
The Santa Clara River Bridge (Br. #53-0687L) is a highly skewed, 741 foot long, 7 span structure. During the earthquake, many of the anchor bolts connecting the

Fig. #7.22. Santa Clara River Br.

girders to the concrete piers pulled out (see Fig 7.22). There was also banging and spalling of the abutments. The most interesting damage was cracking of the girders where they connected to the cross frames. The cross frames were staggered due to the bridges skew. These cracks were probably initiated through fatigue and propagated by the earthquake. It has long been known that staggered cross frames are a serious maintenance problem for steel bridges. Pico-Lyons Overcrossing (Br. #53-1783) is a 2 span continuous plate girder bridge. During the earthquake the restrainers, anchor bolts,
